**DEPARTMENT OF TRANSPORTATION**

Contract #: 04-0120F4Cty: SF/ALA Rte: 80 PM: 13.2/13.9File #: 69.28**WELDING INSPECTION REPORT****Resident Engineer:**Siegenthaler, Peter**Address:** 333 Burma Road**City:** Oakland, CA 94607**Report No:** WIR-025669**Date Inspected:** 19-Jul-2011**Project Name:** SAS Superstructure**OSM Arrival Time:** 1500**Prime Contractor:** American Bridge/Fluor Enterprises, a JV**OSM Departure Time:** 300**Contractor:** Zhenhua Port Machinery Company, Ltd (ZPMC), Changxing Island **Location:** Shanghai, China**CWI Name:** See Below**CWI Present:** Yes No**Inspected CWI report:** Yes No N/A**Rod Oven in Use:** Yes No N/A**Electrode to specification:** Yes No N/A**Weld Procedures Followed:** Yes No N/A**Qualified Welders:** Yes No N/A**Verified Joint Fit-up:** Yes No N/A**Approved Drawings:** Yes No N/A**Approved WPS:** Yes No N/A**Delayed / Cancelled:** Yes No N/A**Bridge No:** 34-0006**Component:** OBG**Summary of Items Observed:**

# WELDING INSPECTION REPORT

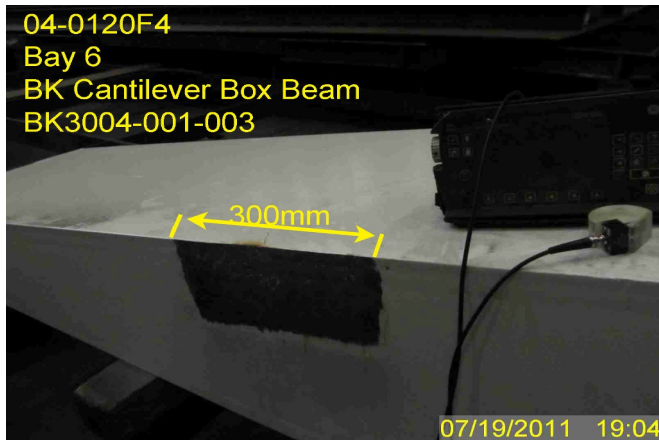
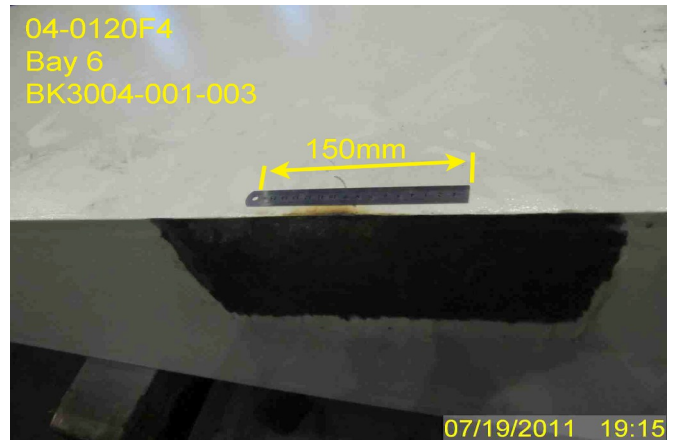
This Caltrans QA inspector received ZPMC non-destructive test (NDT) per ZPMC #09774, Item 1 for OBG Bike Path cantilever box beam BK3004-001-003 assembly/ weld in Bay 6. However, QA observed that the paint removal at the weld was not enough for the required QA UT inspection. The test coverage require a minimum of 10% of the weld to be tested. The weld measured 4700mm and paint removal was approximately 300mm and required minimum length is 470mm. This QA inspector informed ZPMC QC inspector Huang Min of the discrepancy. Huang Min met with Bay 6 Shop Leader in regards with removing more paint. The Shop Leader stated that no one is available to perform paint removal. ZPMC QC inspector Huang Min cancelled the QA UT.

The following digital pictures illustrate paint removal area.
